# The Problem

# Impact Hammer Tests

# Acoustic Camera Tests

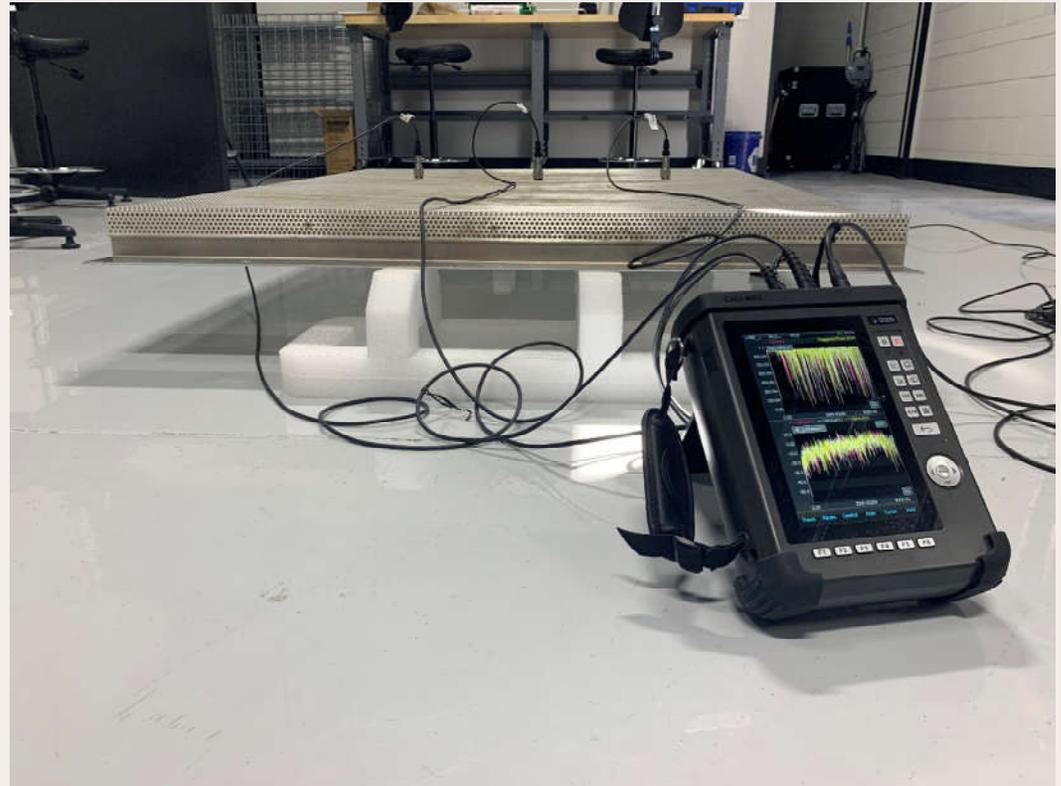
- 3 accelerometers
- 12 measuring positions
- Modal analysis shows panel resonances that match the acoustic spectrum of the building

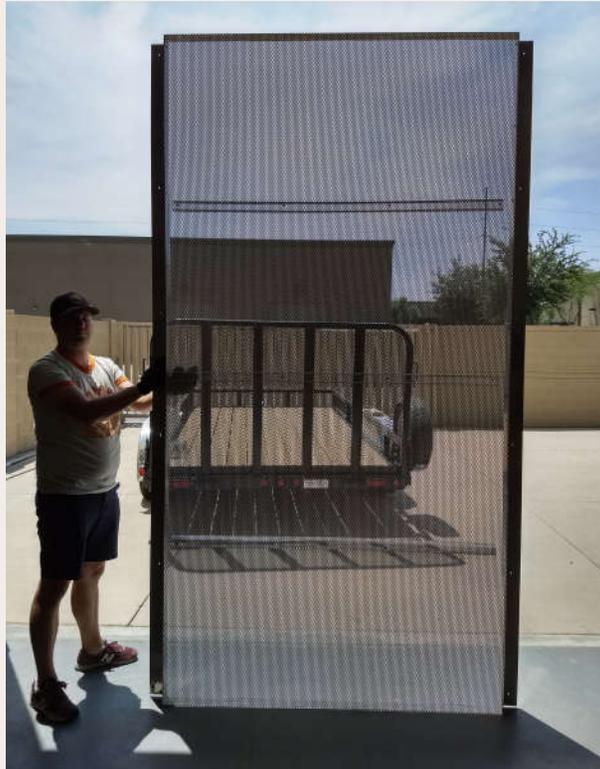
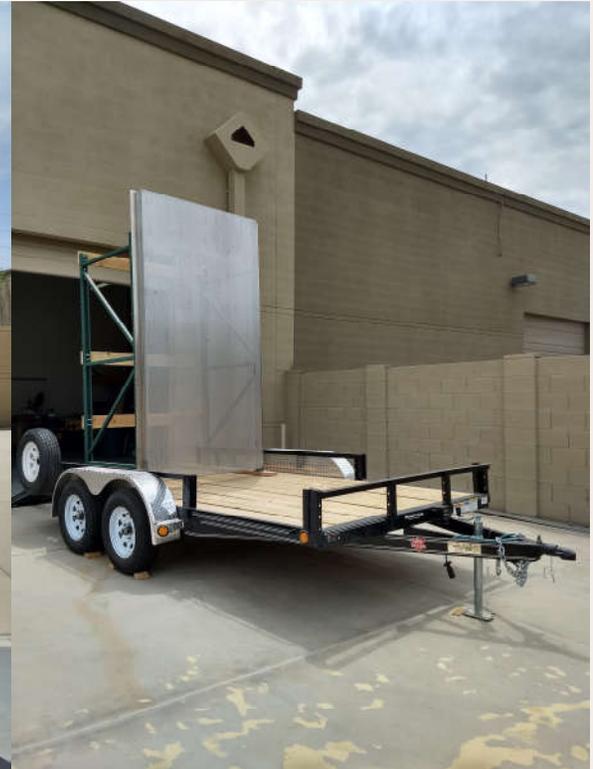
- At about 18 mph, the panel starts to whistle.
- At 20-30 mph, it really gets going.

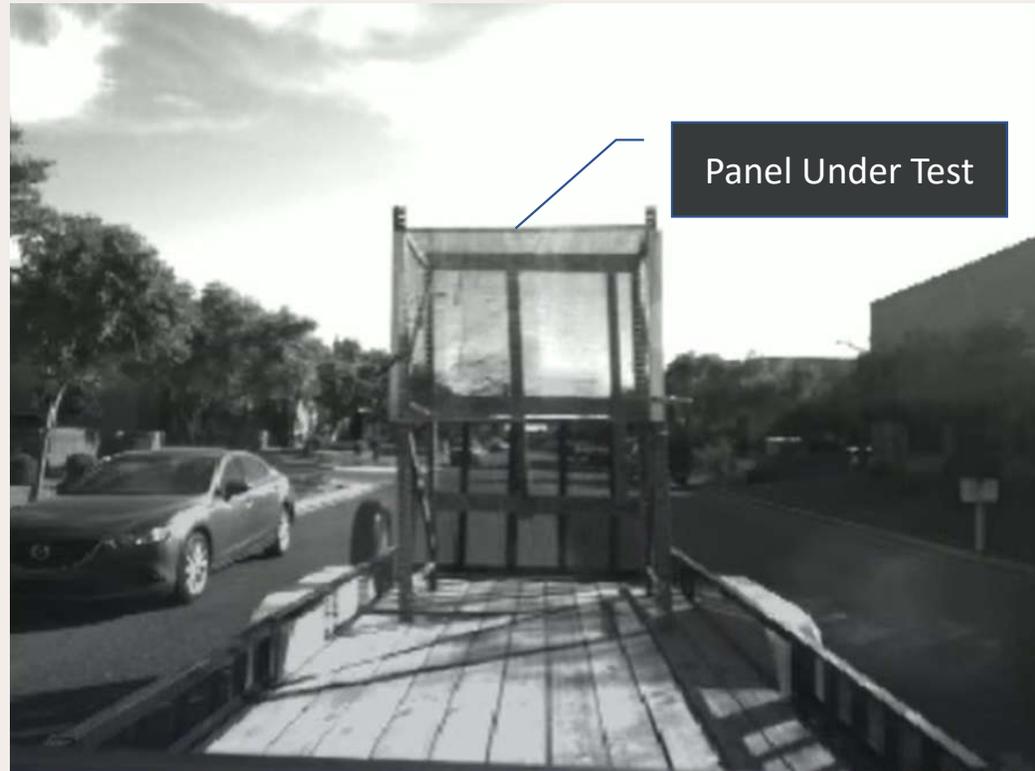
- Sound Camera operator located in the bed of the truck pulling the trailer
- No lab members were harmed during this project

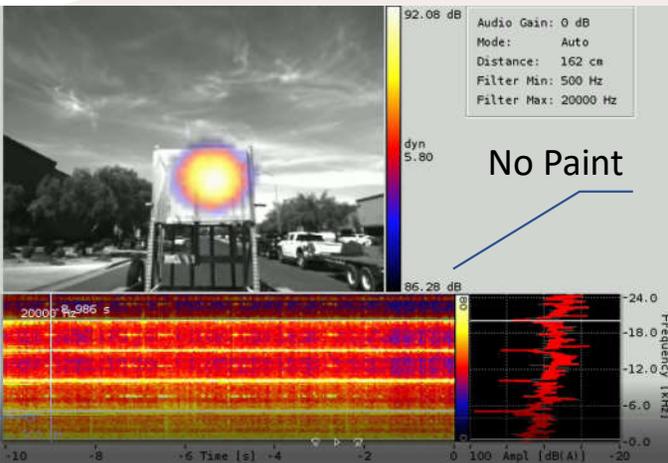
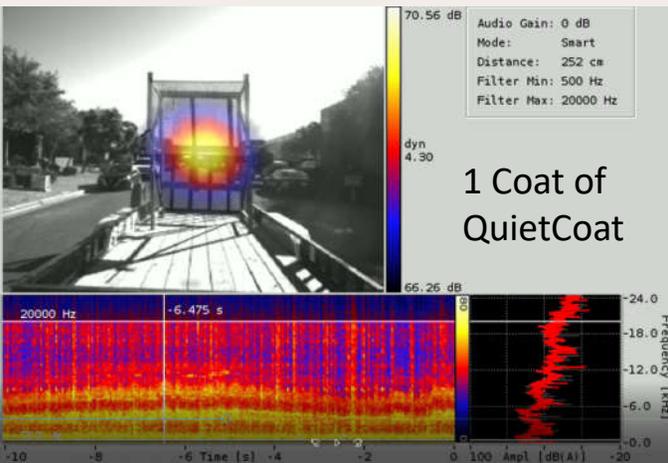
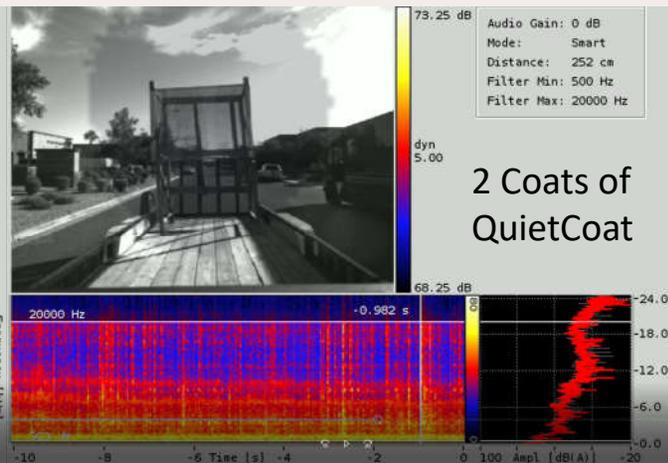
Sharp lines in the spectrogram show the harmonic resonance of the panel

With the Quiet Coat applied, the harmonics dissipate then disappear
